CAPITAL RESTORATION

*St. Clement Catholic Church, Lakeview Neighborhood,
Chicago*

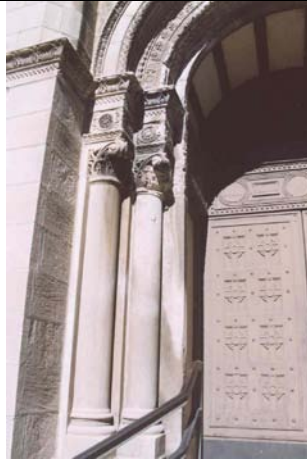
Fig 2. Capital in the portico selected for sample stone repair.

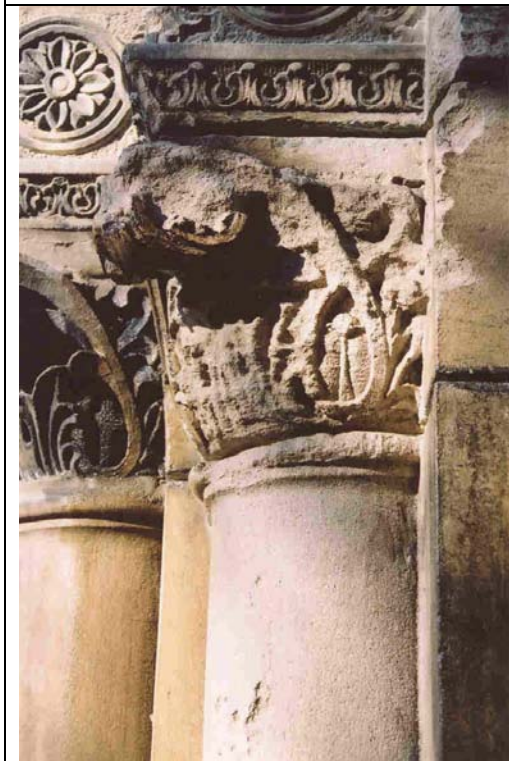
Fig 3. Condition of the capital before repair.
