# CAPITAL RESTORATION

*St. Clement Catholic Church, Lakeview Neighborhood,  
Chicago*

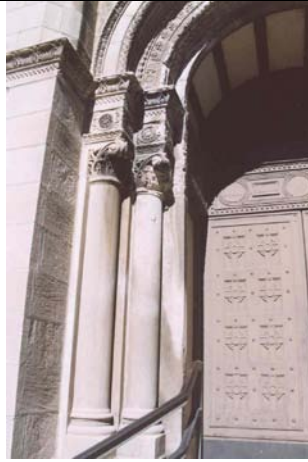
Fig 2. Capital in the portico selected for sample stone repair.

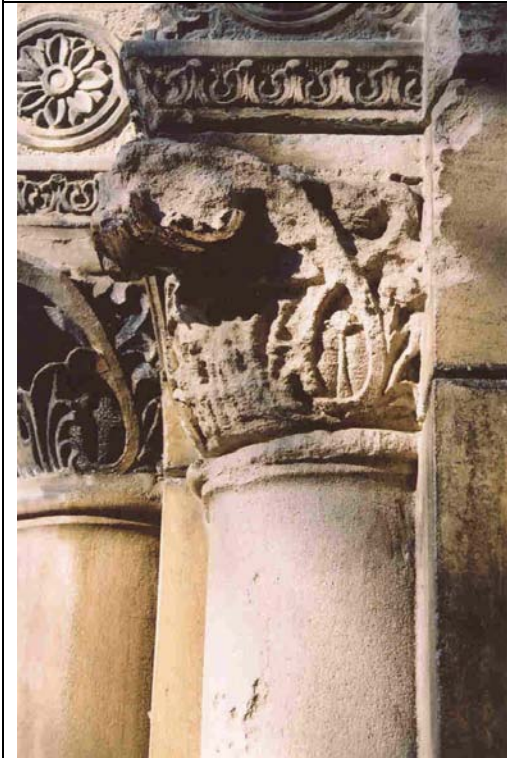
Fig 3. Condition of the capital before repair.
