LIMESTONE RESTORATION

4601 North Beacon, Chicago Il

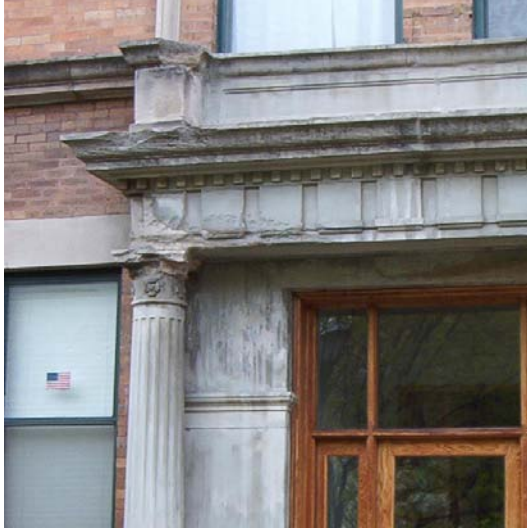
Fig 1. Before. This limestone portico was chemically cleaned to remove stains and discoloration.
