SANDSTONE RESTORATION PROJECT

1510 North Dearborn, Chicago

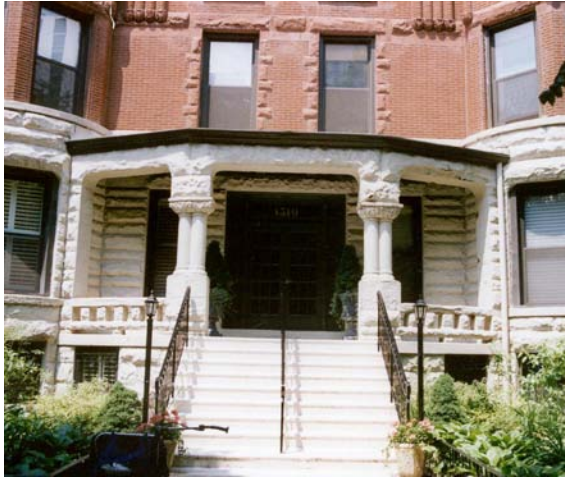
Before: Sandstone is painted, trapping water in the stone and obscuring the carved details.

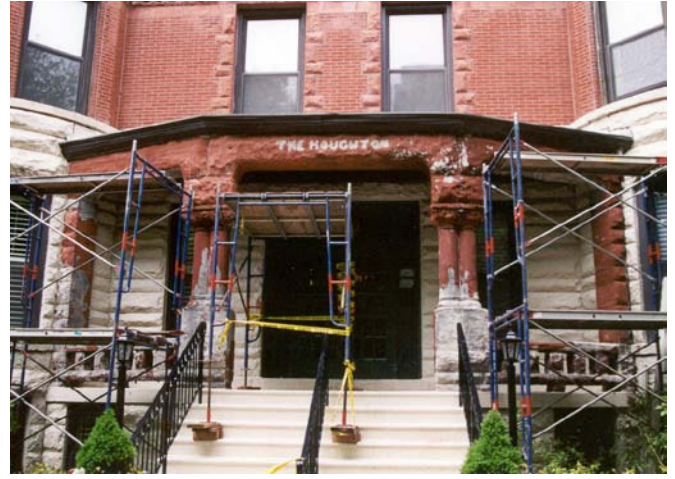
During: Paint has been stripped off of much of the portico.

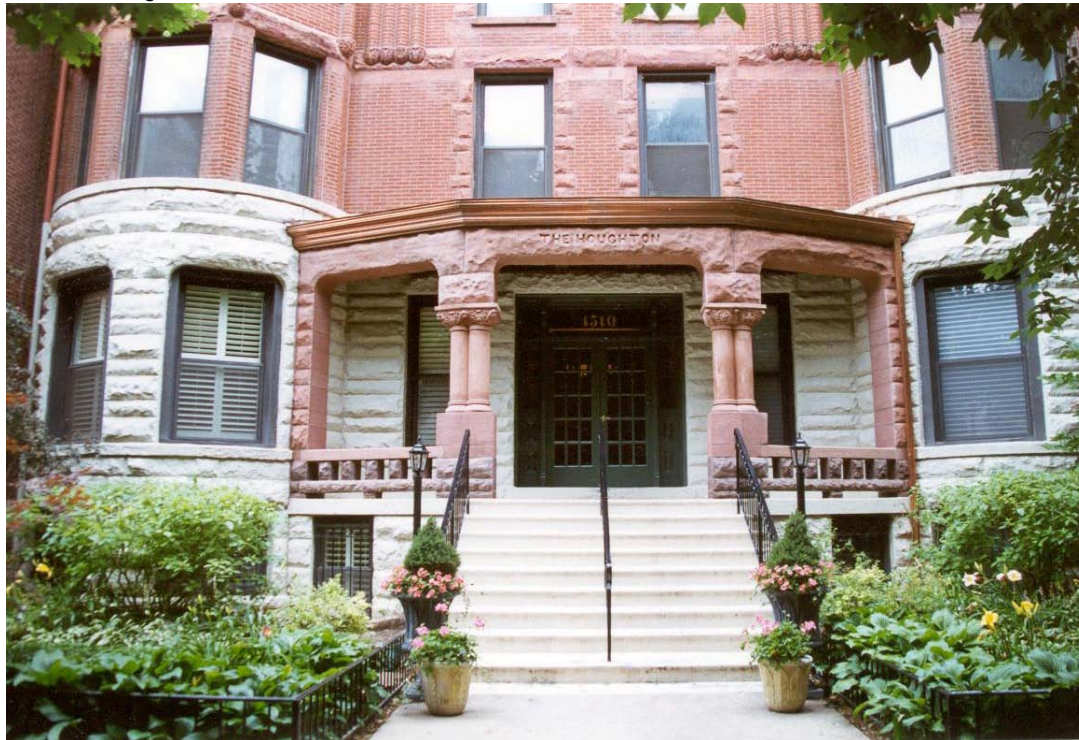
After: Portico has been stripped of paint, the carved details are patched/recarved and the stone has been repointed. Removal of the white paint from the first floor was not included in this phase.

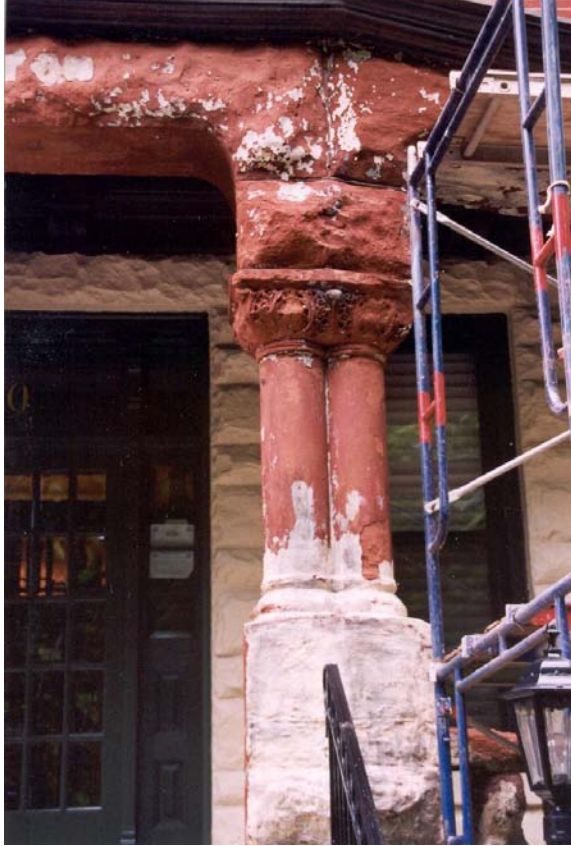
Most of the paint has been stripped from the columns. What is left must be removed from the stone by hand.

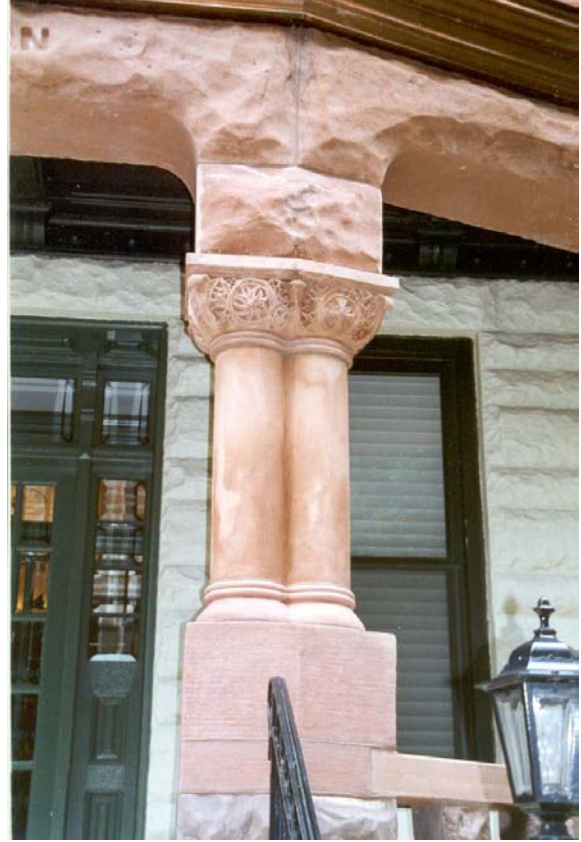
After restoration is completed, the stone features its original carved and tooled appearance.
